Engineering Investigations and Durability Problems of the Construction Materials of the Roman Babylon of Egypt

Sayed Hemeda¹, Adel I. M. Akarish², Amr Abu El-Nagga¹

¹Conservation Department, Faculty of Archaeology, Cairo University, Cairo, Egypt

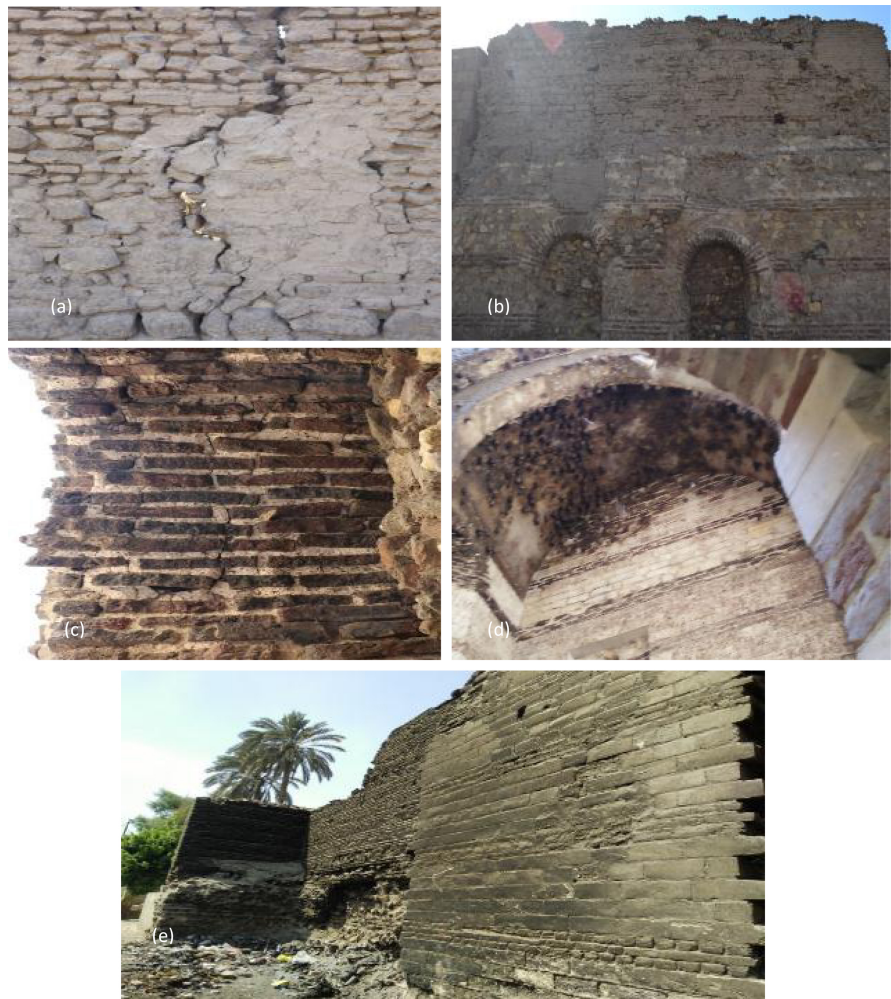
Figure 12. Structural deficiency of many walls and towers of the Babylon of Egypt: (a) cracks and fissures in the vertical walls; (b) permanent deformation of the bricks in the zone of the borders and main wall of the façades; (c) danger cracks appeared in some towers; (d) one very significant source of surface damage resulted from the fesses of bats that inhabited the tower in thousands. And (e) separation between the façade and the radial walls are obvious.

Figure 12 presents the observed main aspects of the structural deficiency of many walls and towers of the Babylon of Egypt. Cracks and fissures took place in the vertical walls. Permanent deformation of the bricks is observed in the zone of the borders and main wall of the façades. Dangers cracks appeared in some towers and separation between the façade and the radial walls are obvious. These damage forms are related to the mechanical actions in particularly the seismic hazards and geotechnical problem of the bearing soil.

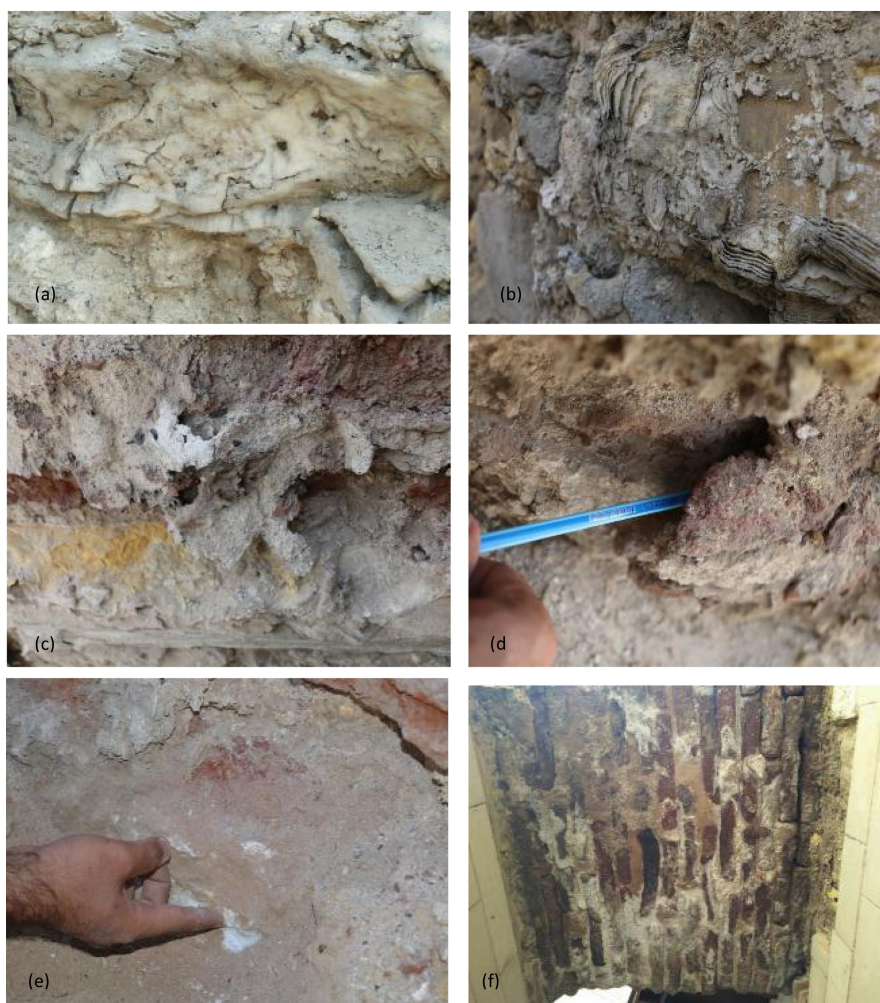
Figure 13. Physical and chemical deterioration forms due to subsurface water rising and salt weathering affecting the roman bricks and structural mortars; (a) and (b) salt efflorescence; (c), (d) and (e) crypto florescence, layers exfoliations and hard black crust formation; (f) brick and joining mortars disintegration due to salt weathering mechanisms.

Figure 13 shows some of the recorded forms of the physical and chemical

deteriorations due to subsurface water rising and salt weathering affecting the roman and byzantine bricks and the joining structural mortars.

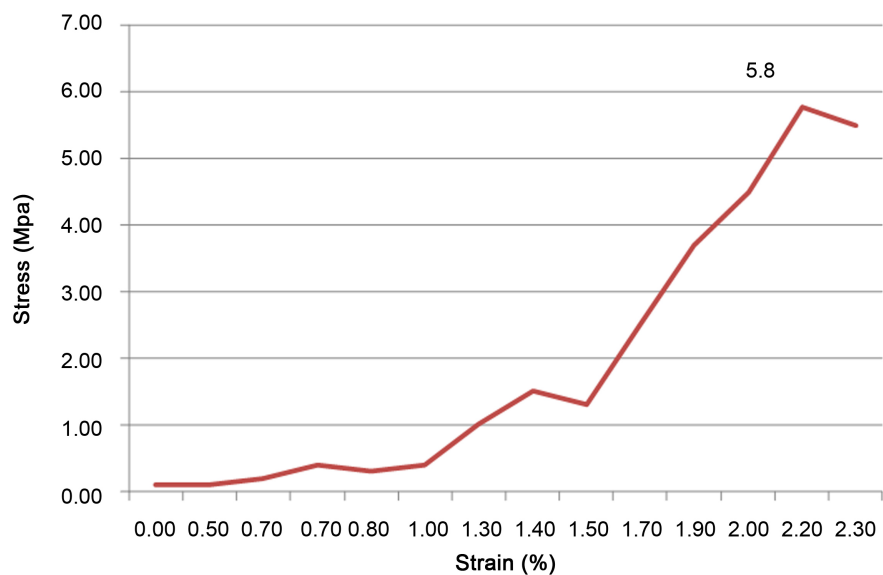
**Figure 16.** Uniaxial compressive stress-strain curve for the Roman bricks under investigation.

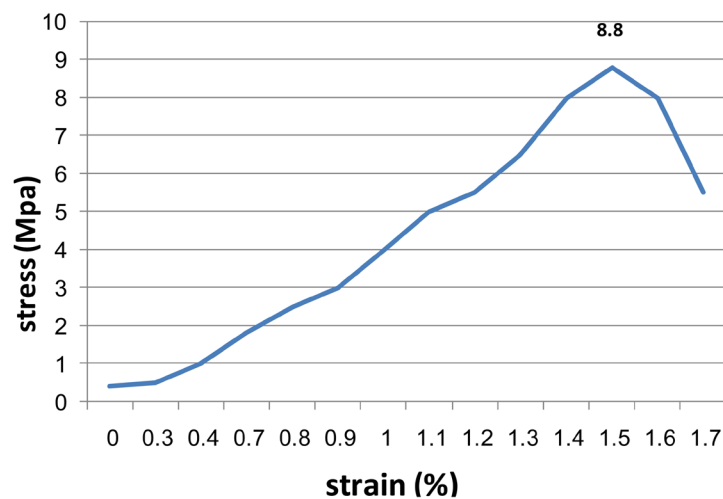
Figure 17. Uniaxial compressive stress-strain curve for the Byzantine bricks under investigation.

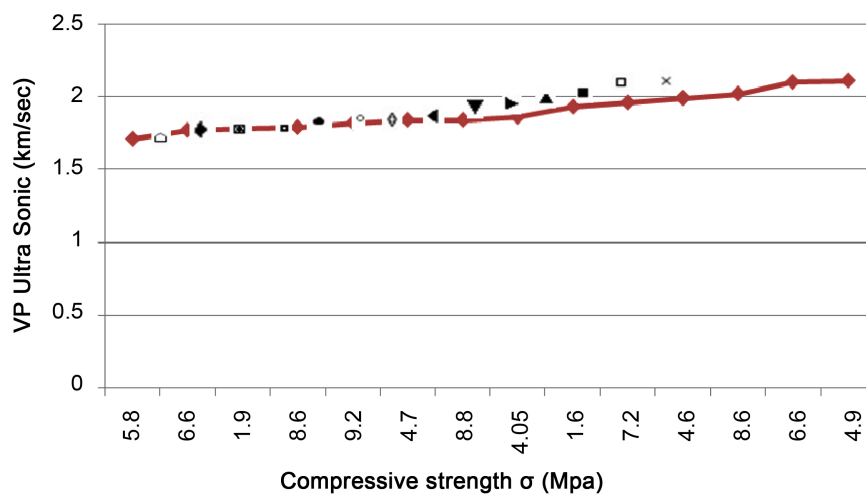
Figure 18. Ultra-sonic wave velocity versus uniaxial compressive strength of the brick under investigation.

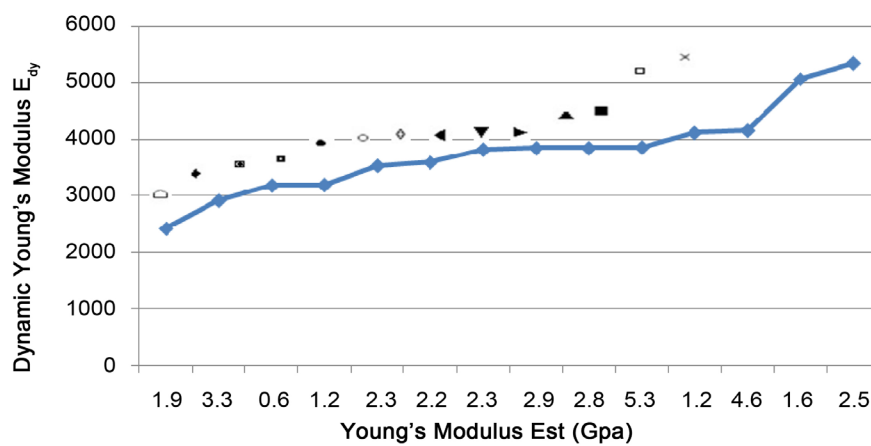
Figure 19. The static modulus of elasticity versus the dynamic modulus of elasticity of the brick under investigation.

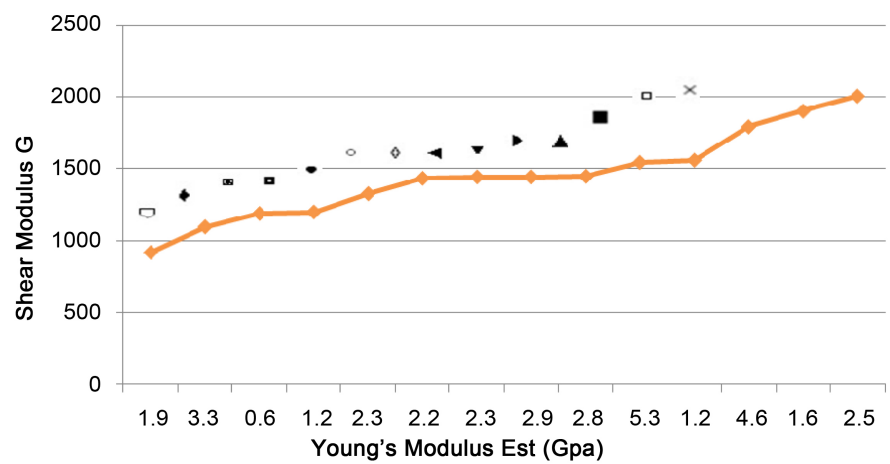
Figure 20. Shear modulus versus static modulus of elasticity of the brick under investigation.

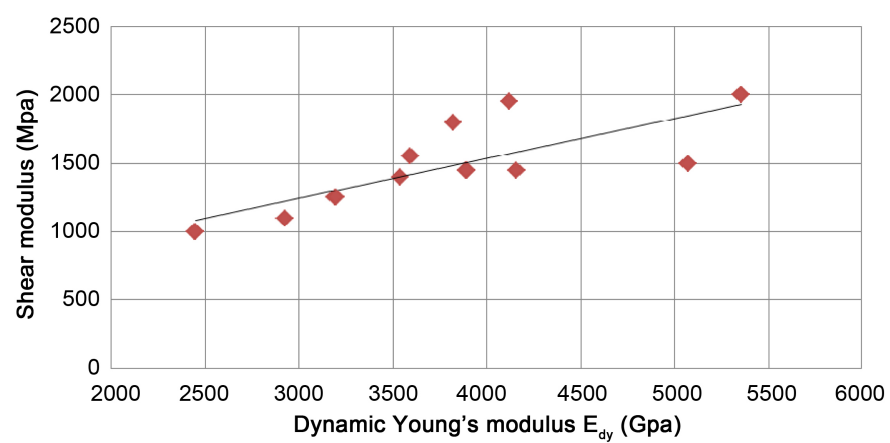
Figure 21. Shear modulus versus dynamic modulus of elasticity of the brick under investigations.

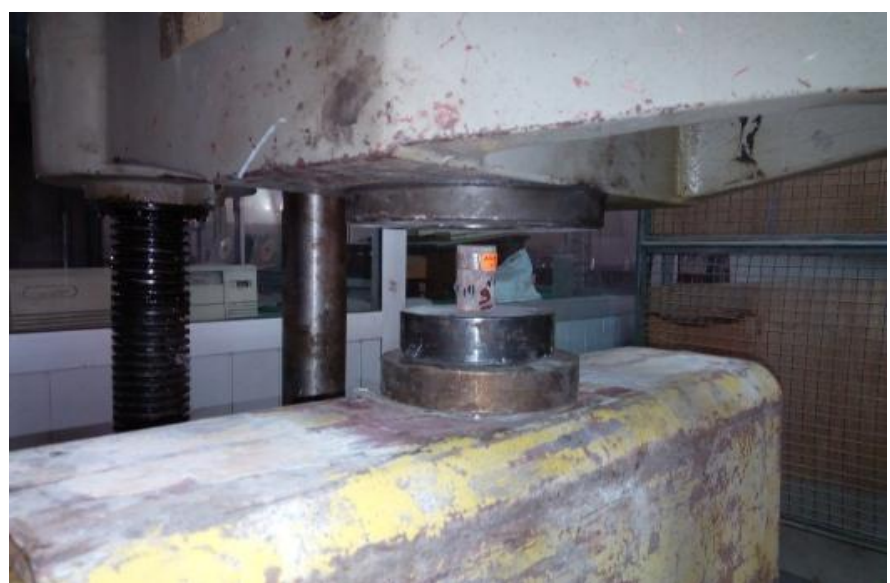
Figure 22. Uniaxial compression test on the brick cylinder samples.

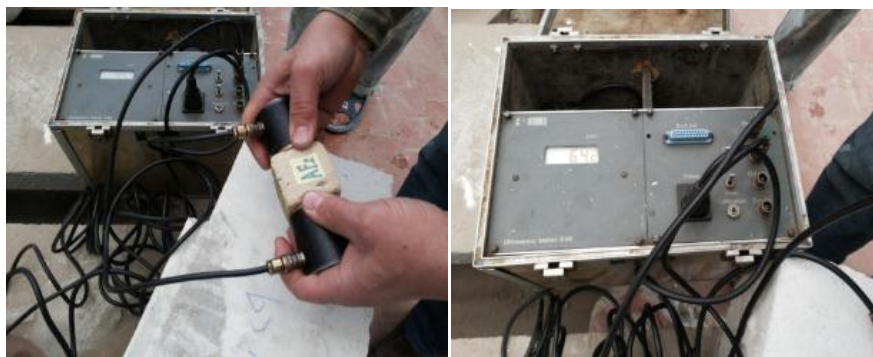
Figure 23. Non-destructive Ultrasonic pulse testing.

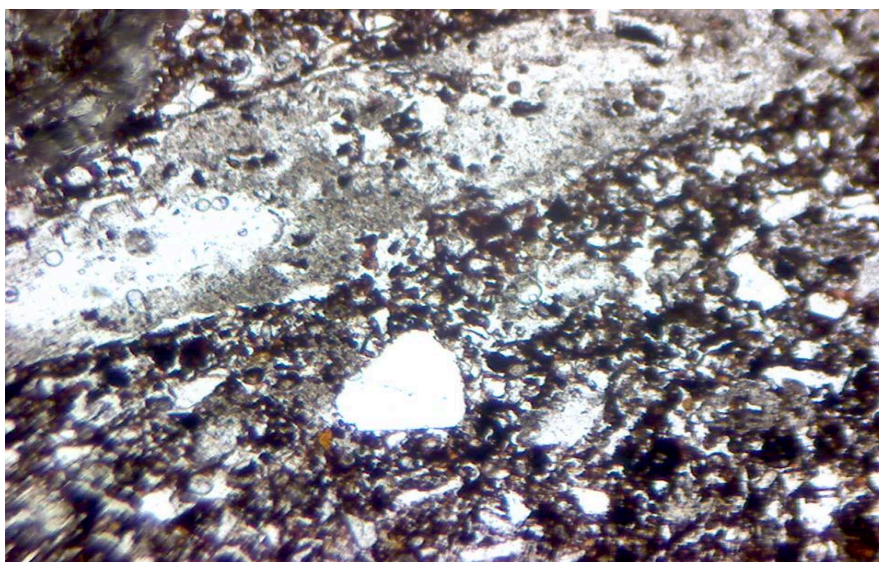
Figure 24. Quartz grains embedded in iron oxides matrix (P. P. L).

Thin section examination (**Figure 24** and **Figure 25**) using the polarizing light microscopy revealed that the studied bricks formed mainly of quartz and feldspar grains. The quartz grains range in size from minor silt sized and very fine to coarse sand size grains. The quartz grains average (70% - 90%) and are generally poorly sorted, subangular to subrounded and sometimes well rounded. They are commonly mono crystalline and exhibit either uniform or undulose extinction; however some composite quartz grains also found. Amorphous silica

in a form of chalcedony filling pores also observed. These quartz grains are embedded in a ferruginous dark brownish groundmass formed mainly iron oxides (hematite) and burnt clays. The iron oxides are commonly found as a dark patches or very fine material. Feldspars (average 7%) are represented mainly by plagioclase and microcline.

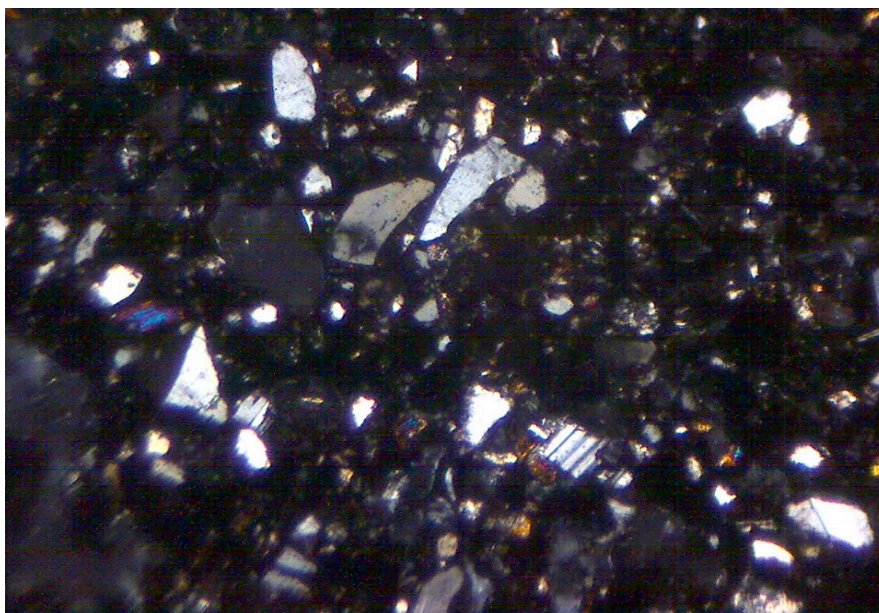
Figure 25. Quartz, mica and feldspar together with amorphous silica.

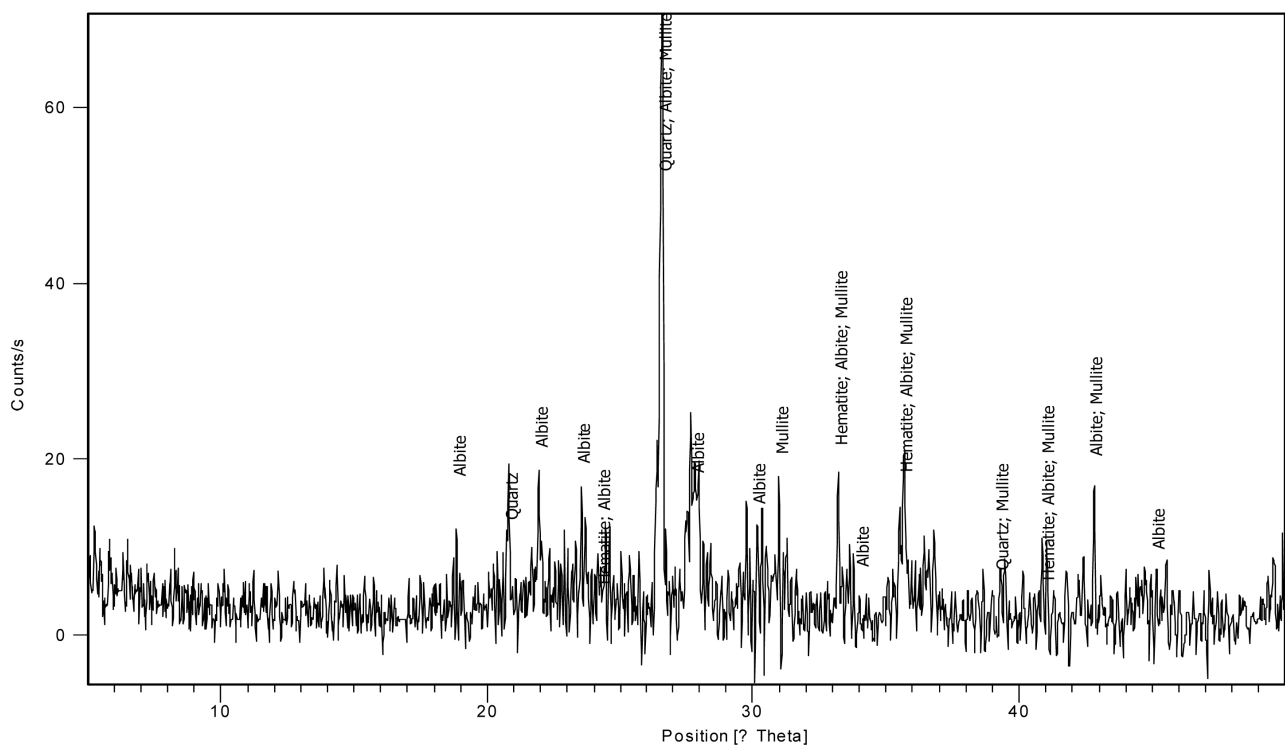
Figure 26. XRD pattern of the Roman bricks under investigations.

The obtained XRD results (**Figure 26** and **Figure 27**) are compatible with those of the petrographic examination. The analysis revealed that the main recorded minerals of the investigated bricks are quartz, feldspars (albite and anorthite), hematite and mullite in some samples. Mullite can consider as secondary product and is might be originated due the burning of the clays (kaolinite) at high temperature.

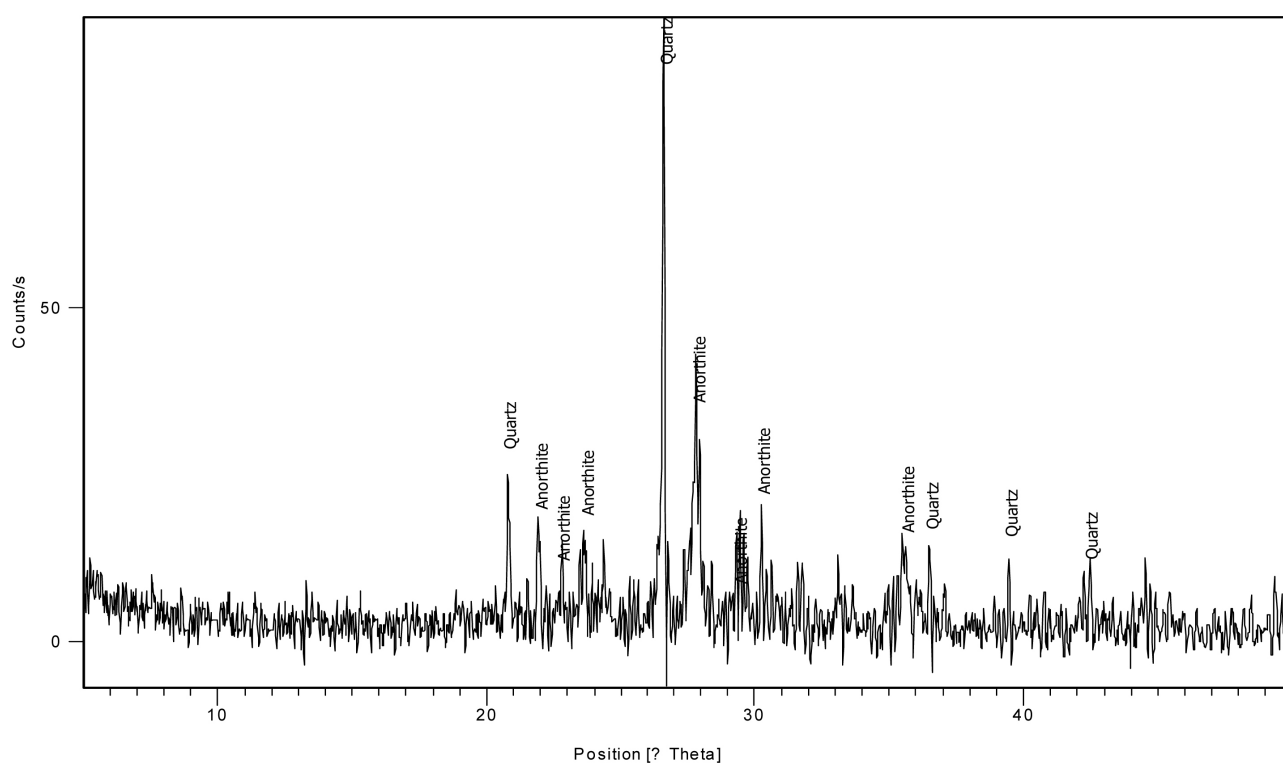
Figure 27. XRD pattern of the Byzantine bricks under investigation.

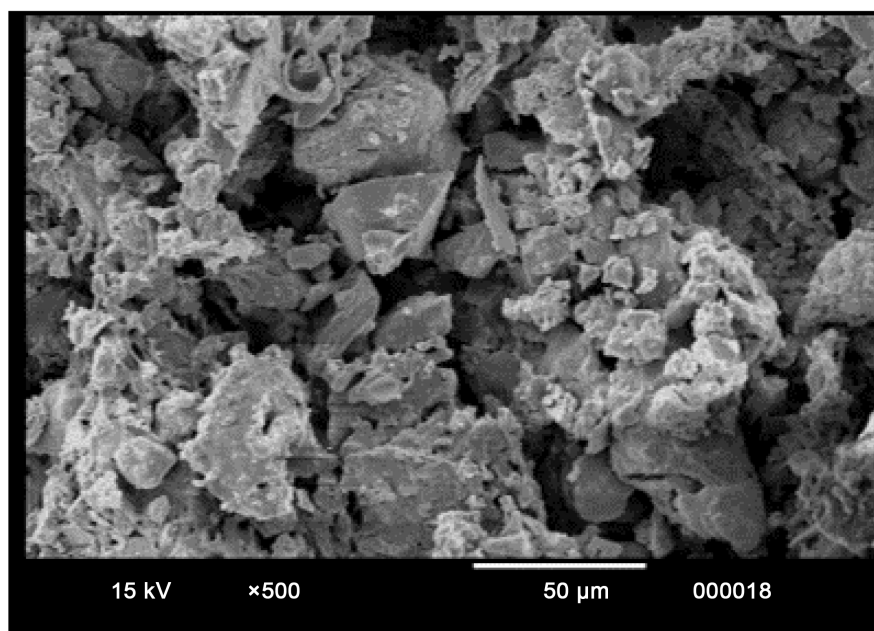
Figure 28. SEM photo micrograph showing the micro structure of the brick with quartz and iron oxides (hematite and magnetite).

SEM examinations (**Figure 28** and **Figure 29**) of the studied brick samples also, proved presence of quartz grains having various sizes ranging from fine to medium spread on a matrix of iron oxides (hematite and magnetite). Also, the morphological investigation indicate that the brick body contains different surface features, such as the wide distribution deteriorated crusts, corroded quartz grains and the presence of some large voids and micro pores, as well as, some disintegration aspects in each grain.

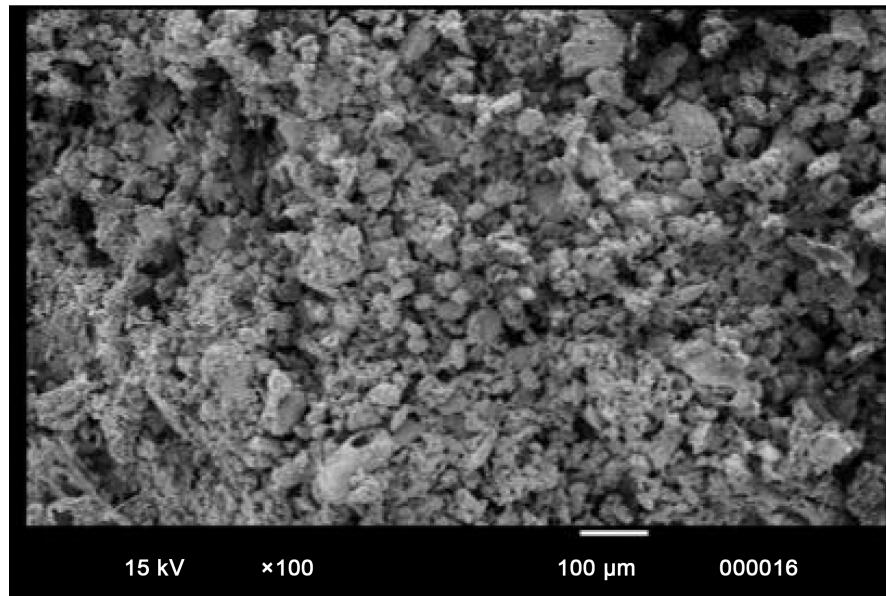
Figure 29. SEM photomicrograph showing the very fine quartz grains scattered on a matrix of iron oxides.

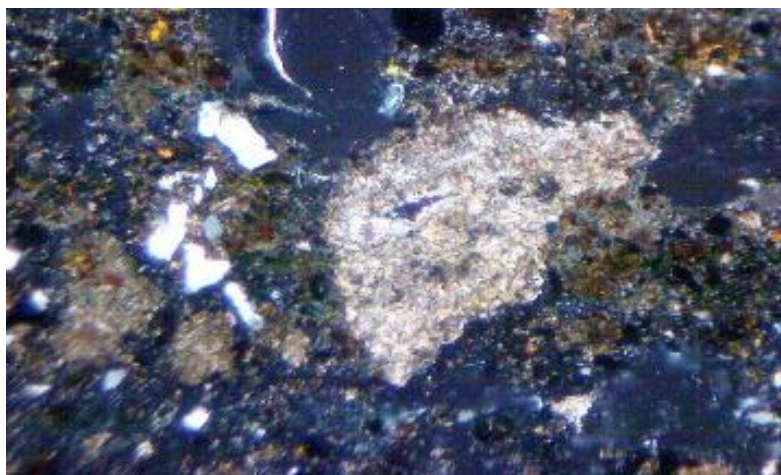
Figure 30. Microscopic photograph showing the quartz granules and gypsum in a ground of lime (P.P.L, sample M1).

For petrographic examinations the collected mortar samples (M1-M3), three thin sections were prepared. The study showed that the investigated mortars (**Figures 30-32**) consist of medium to coarse, sub rounded to rounded mono crystalline quartz grains as well as some Feldspars, which are the main components of the sand used for mortar preparation. These grains are embedded in a ground mass made up of very minute crystals of microcrystalline carbonate ooze (micrite), as well as large granules of calcite, with a small percentage of gypsum in some samples. Aggregates of the red bricks (Quartz + iron oxides) as well as

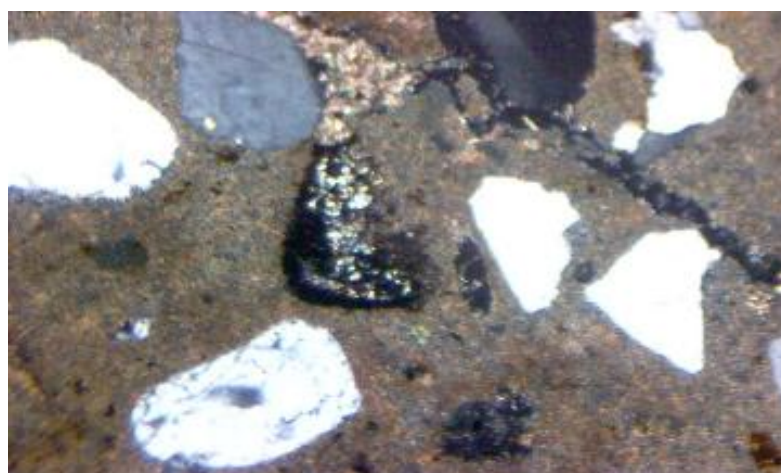
Figure 31. Microscopic photograph showing aggregates of lime and ceramic brick together with quartz grains (C.N, sample M2).

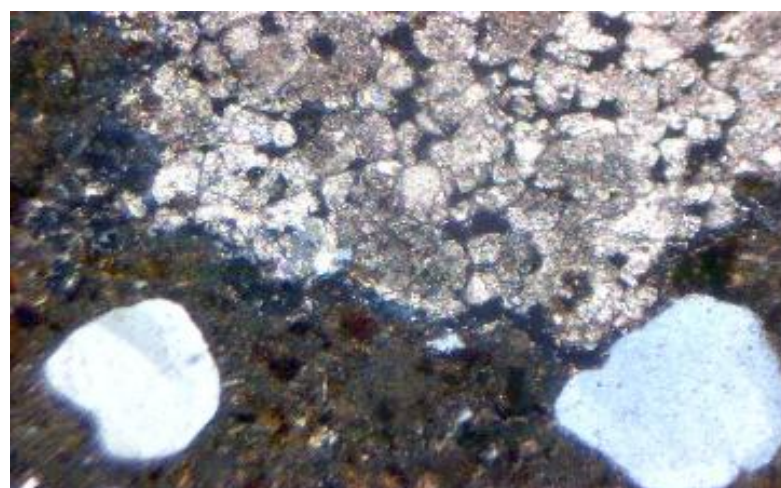
Figure 32. Microscopic photograph showing coarse limestone aggregate, quartz and black (carbon) fractions (P.P.L., sample M3).

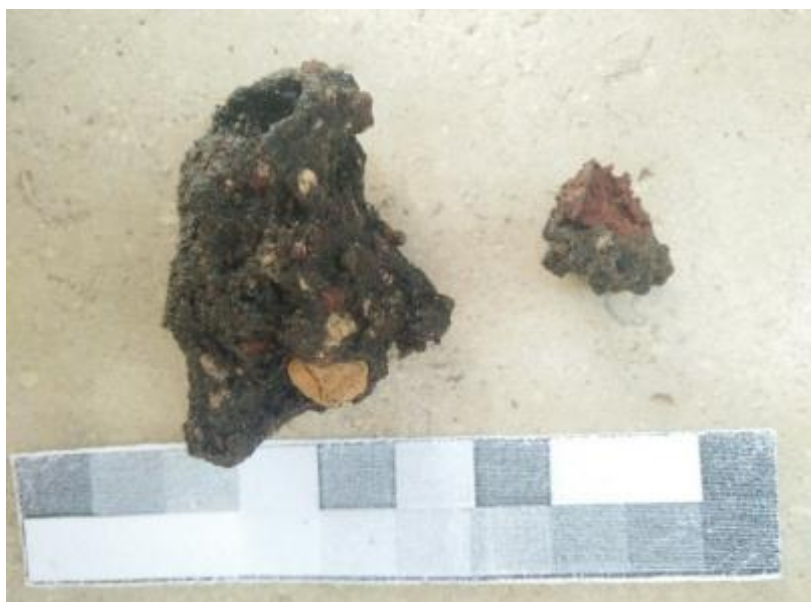
Figure 33. Mortar sample after etching by dilute HCL, Note that: limestone, brick and furnace slag fractions are detected.

Etching a hand specimen mortar sample with dilute HCl (10%), it was clear to recognize the main materials used in the mortar, **Figure 33**. Such include small flakes and aggregates of limestone red brick as well as sand grains and lime, which corroborate the petrographic investigations.

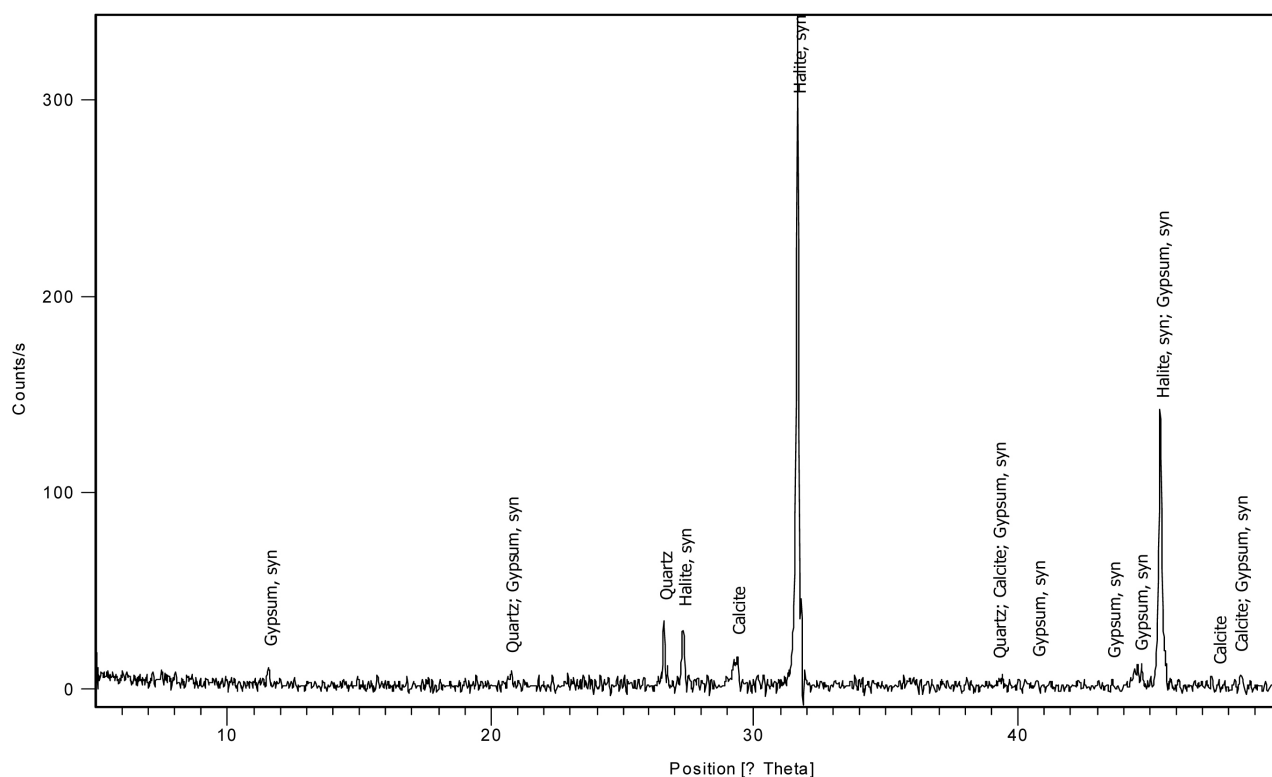
Figure 34. X-ray diffraction pattern of structural mortars from Babylon of Egypt M2.

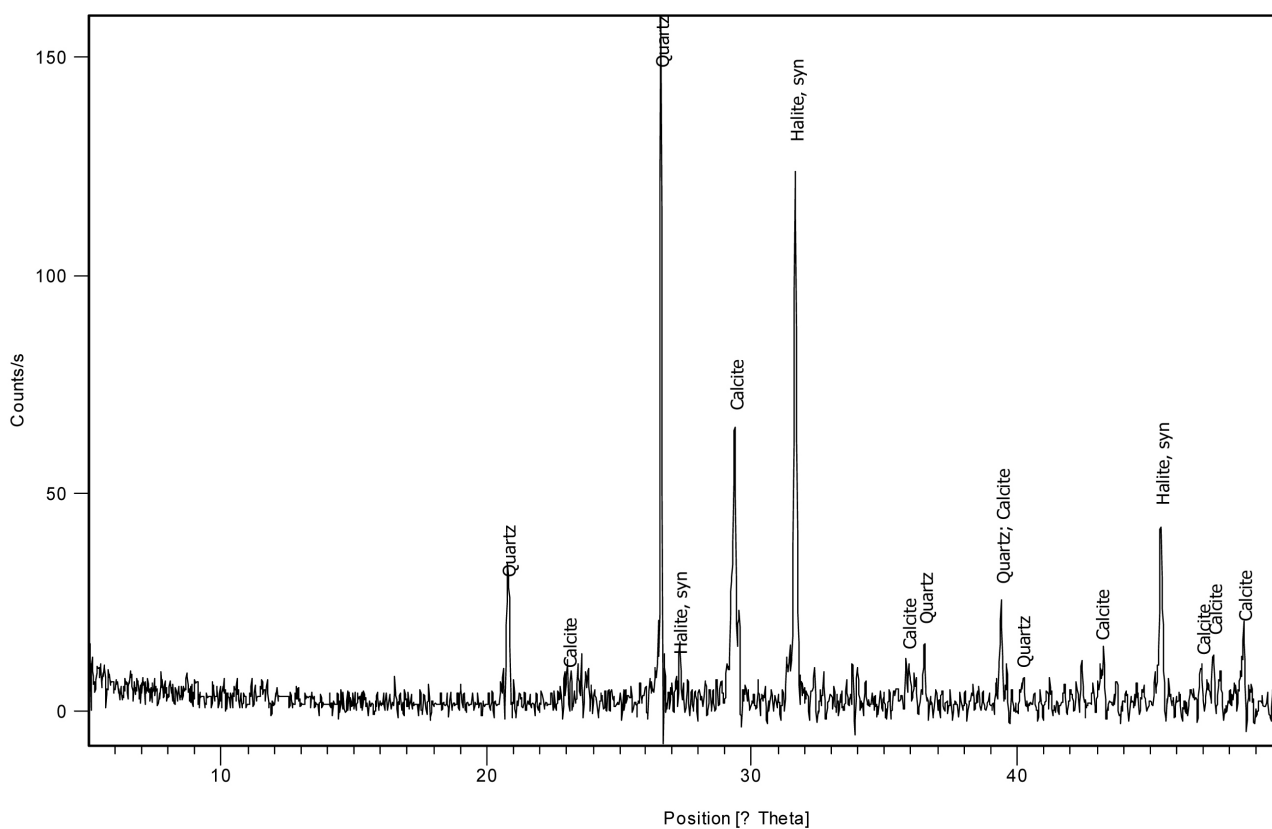
Figure 35. X-ray diffraction pattern of structural mortar from Babylon of Egypt M3.

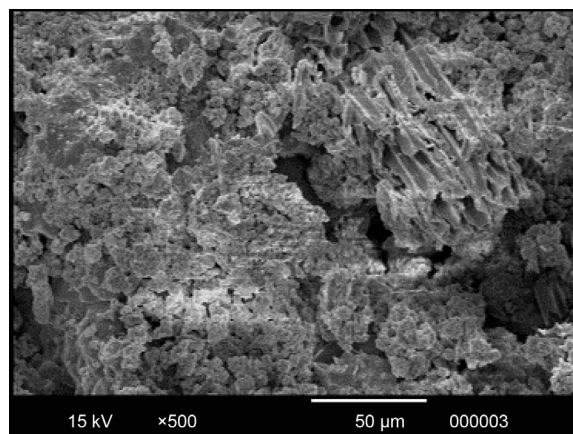
Figure 36. SEM analysis showing quartz granules of different sizes, lime granules used in the mortar and some gypsum granules and salts of the eye.

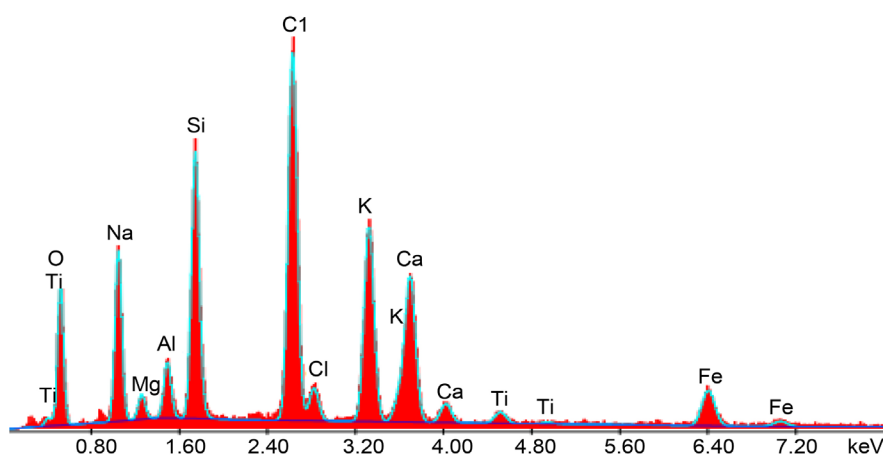
Figure 37. EDX microanalysis showing the intensive presence of Halite in the mortar composition.

related EDX analysis showed the presence of alumina and silica Al, Si This indicates that it is a hydraulic lime mortars (**Figure 37**, **Figure 39**, **Figure 41** and **Figure 44**).

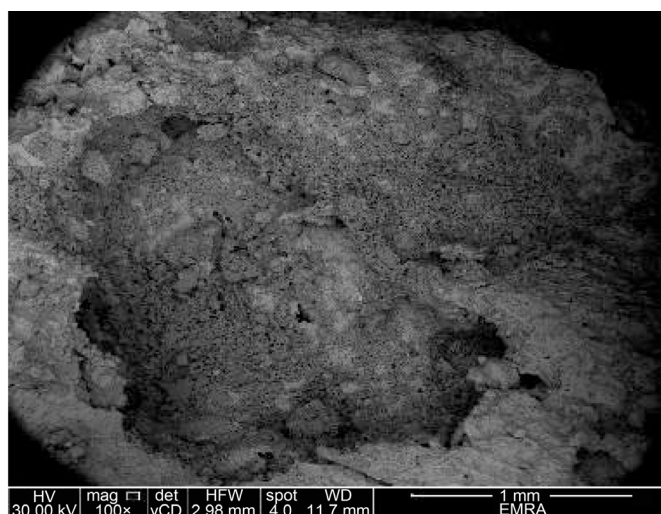
Figure 38. SEM image showing the brick aggregate fractures inside the mortar sample.

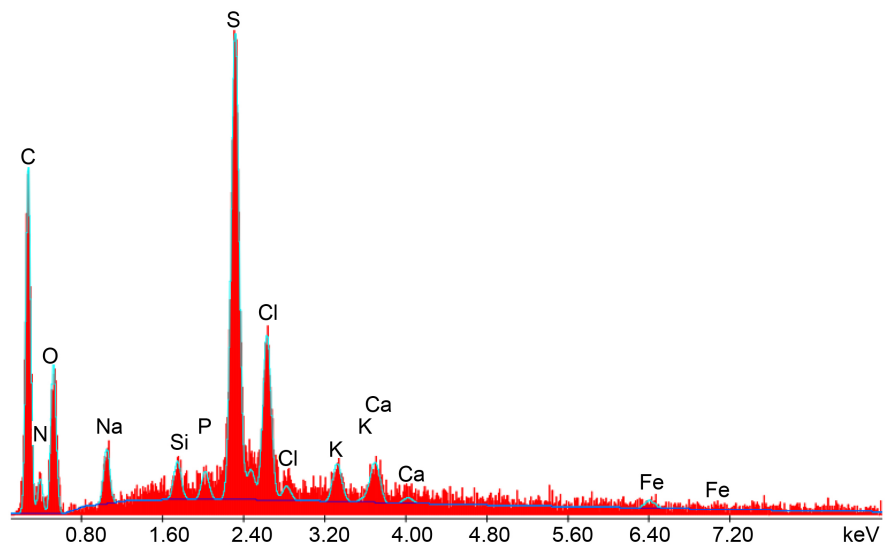
Figure 39. EDX microanalysis showing the presence of alumina, silica, Halite and Iron oxides in the mortar sample.

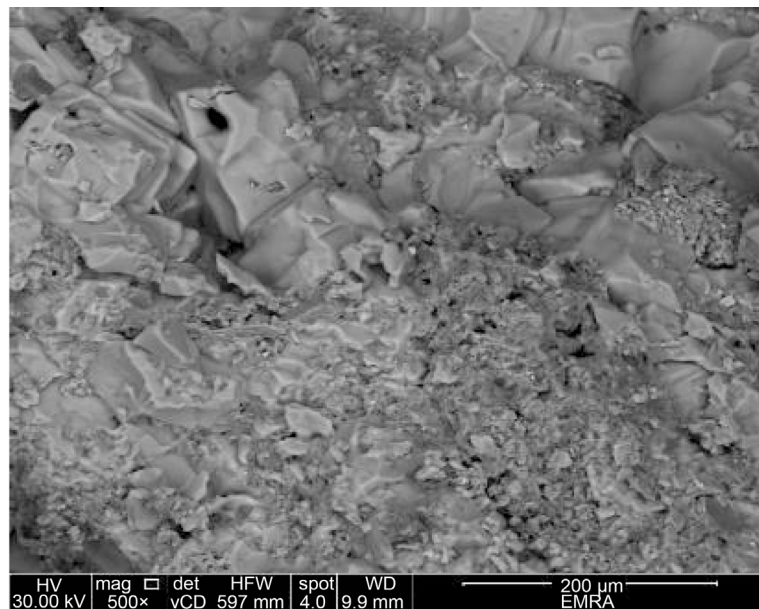
Figure 40. SEM image showing the presence of limestone and bricks aggregates and the contamination with the chloride salts.

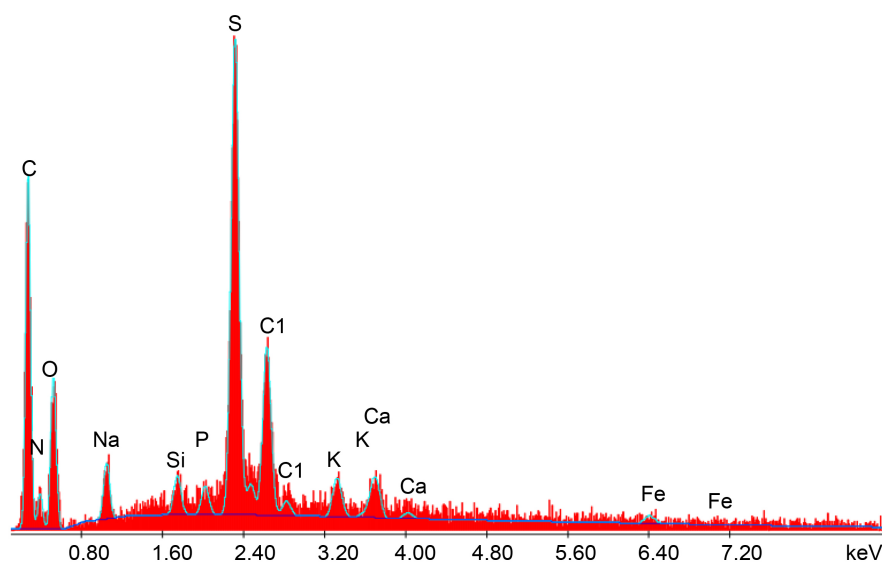
Figure 41. EDX microanalysis showing the presence of Carbon and residues of organic matter in the mortar samples.

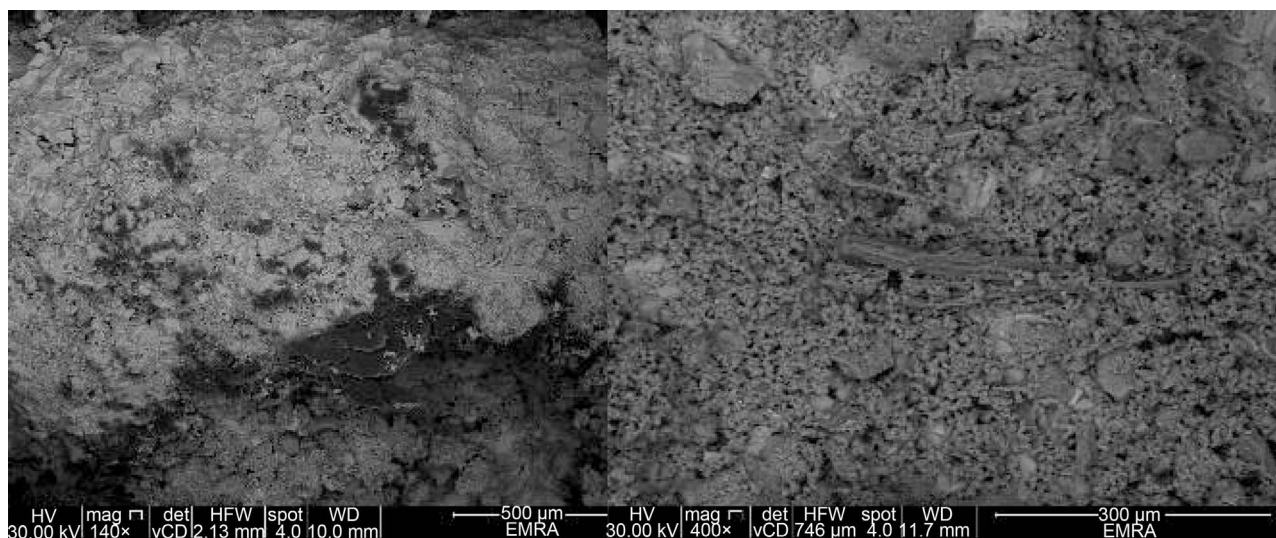
Figure 42. SEM image showing the disintegration of the structural mortars due to the ground water and salt weathering.

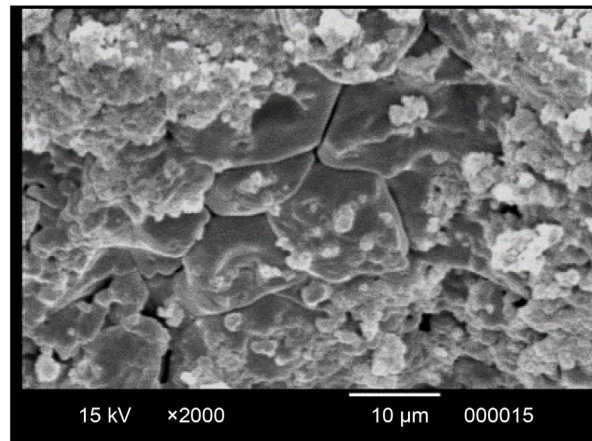
Figure 43. SEM image showing Quartz, Calcite and Halite Crystals in the mortar sample.

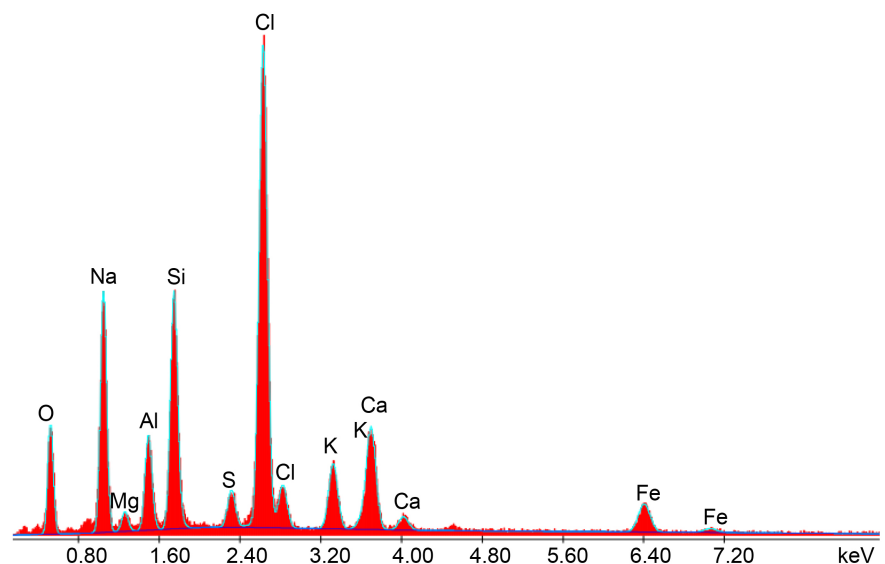
Figure 44. EDX microanalysis showing the presence of alumina and silica in the mortar that confirms that it is a hydraulic mortar.

nitrogen and oxygen P, N, C (**Figure 44**). Shows the presence of alumina and silica inside the mortar composition, confirming that is a hydraulic mortar [20].
